CF6 HIGH PRESSURE COMPRESSOR AND TURBINE CLEARANCE EVALUATIONS

M.A. Radomski and L.D. Cline
General Electric Company

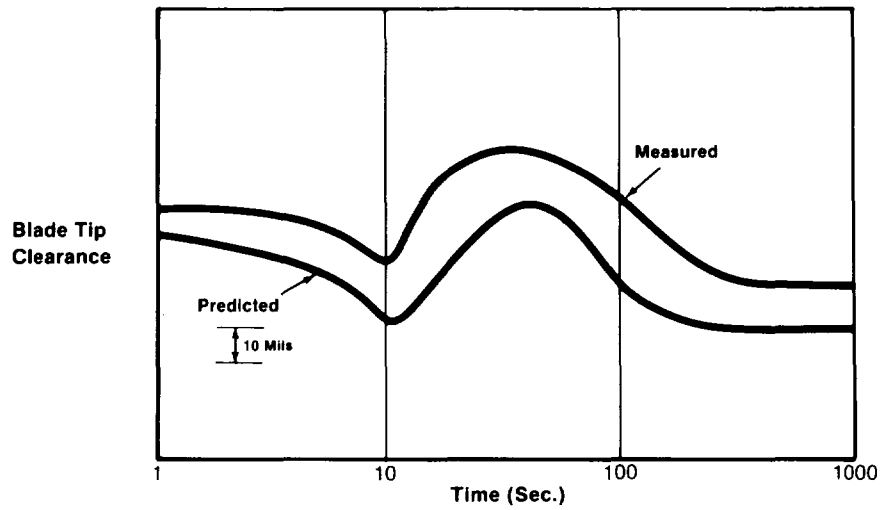
FIGURE 25

Representative plots of a throttle burst (steady-state idle to steady-state take-off) and throttle chop (steady-state take-off to steady-state idle) are presented in Figures 25 and 26.

Blade Tip Clearance Transient Response — Throttle Burst From Idle To Take-off

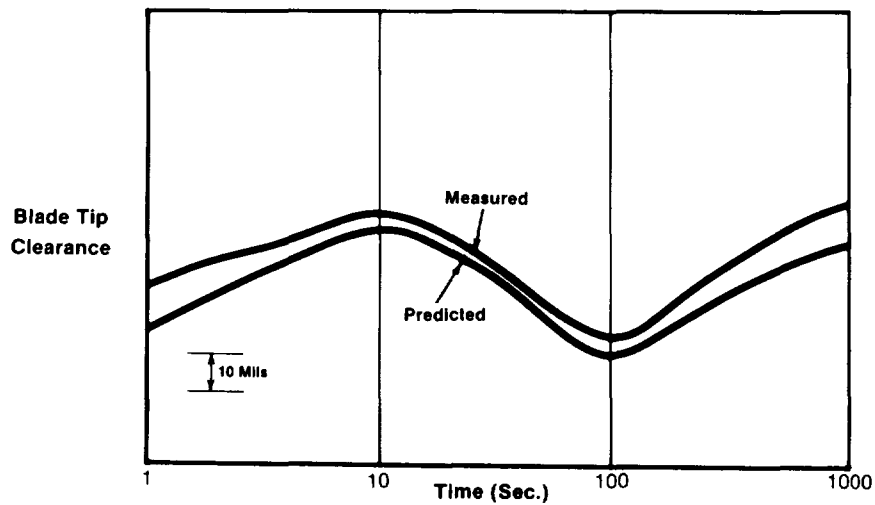
FIGURE 26

Blade Tip Clearance Transient Response — Throttle Chop From Take-off To Idle
